Manhole Inspection Summary

Manhole # S49OO_003MH

Insp Date: **5/13/08 10:12 AM**

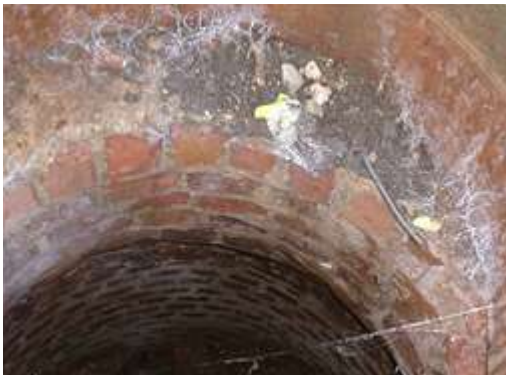
Defect 1

Frame Offset: **4** (in.) Condition: ☐ Sound ☐ Cracked ☒ **Leaks**

frame leaks

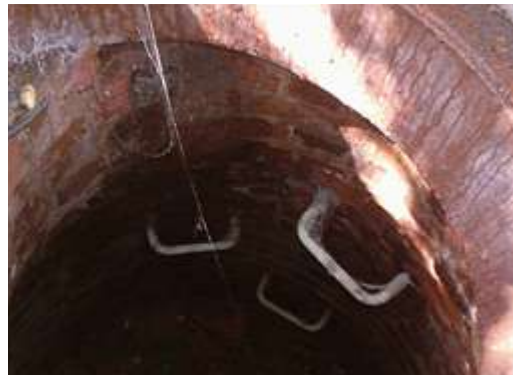
Defect 2

Infiltration: ☐ None ☒ **Joint** ☐ Cracks ☒ **Mortar** ☐ Roots ☐ Wall

Infiltration: ☐ None ☐ Joint ☐ Cracks ☐ Mortar ☐ Roots ☒ **Wall**

infiltration

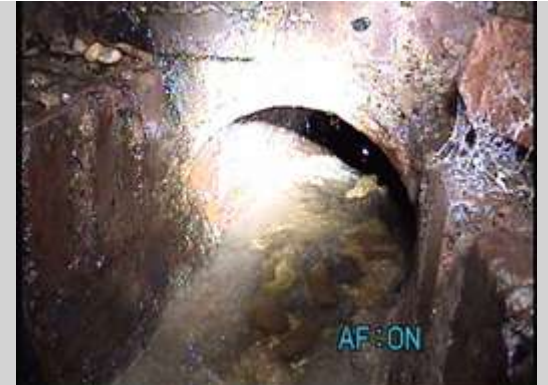
12 O'Clock Outflow

8 in. Circular Gravity Sewer
Pipe Out @ 12 O'Clock

Pipe Height: **8.4** (in.) Rod and Bar (Angled)
Pipe Material: **Clay** ☐ Pipe Lined
Invert Depth: **8.20** (ft.) Flow Characteristics: **Slow**
Deposits: ☒ None ☐ Mud ☐ Sludge ☐ Debris ☐ Grease
Silt Depth: (in.) Deposits Extent:
Infiltration: **None** Pipe Seal Cond: **Sound**

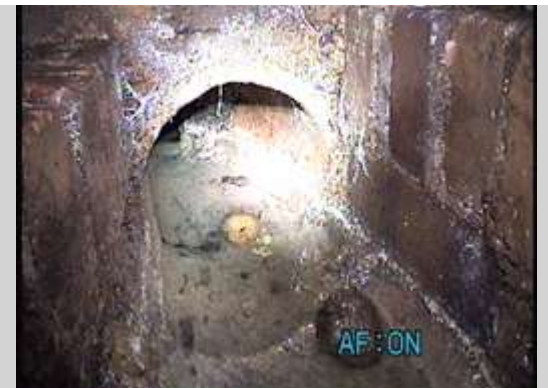
3 O'Clock Inflow

8 in. Circular Gravity Sewer
Pipe In @ 3 O'Clock

Pipe Height: **8.4** (in.) Rod and Bar (Angled)
Pipe Material: **Clay** ☐ Pipe Lined
Invert Depth: **8.10** (ft.) Flow Characteristics: **Slow**
Deposits: ☒ None ☐ Mud ☐ Sludge ☐ Debris ☐ Grease
Silt Depth: (in.) Deposits Extent:
Infiltration: **None** Pipe Seal Cond: **Sound**
